## COMMERCIAL WINDSTORM MITIGATION REPORT

East Lake Woodlands Condominium Unit Four Association, Inc.

## COMMERCIAL WINDSTORM MITIGATION REPORT (OIR-B1-1802)

101-120 Martha Ln, Building 1

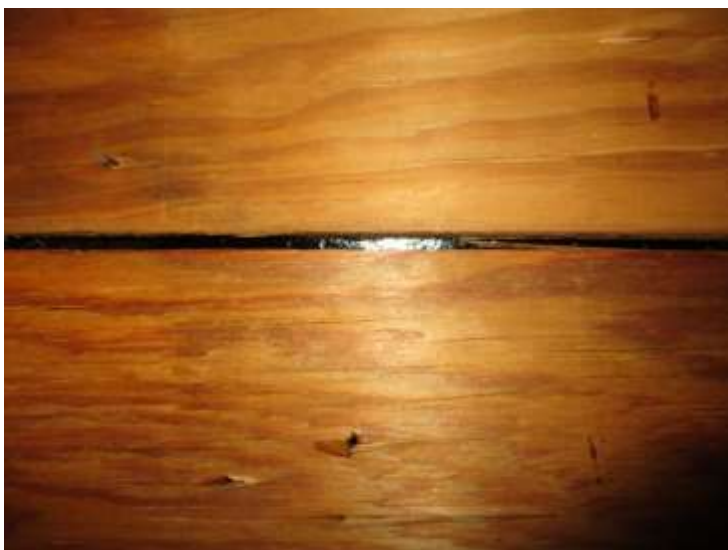
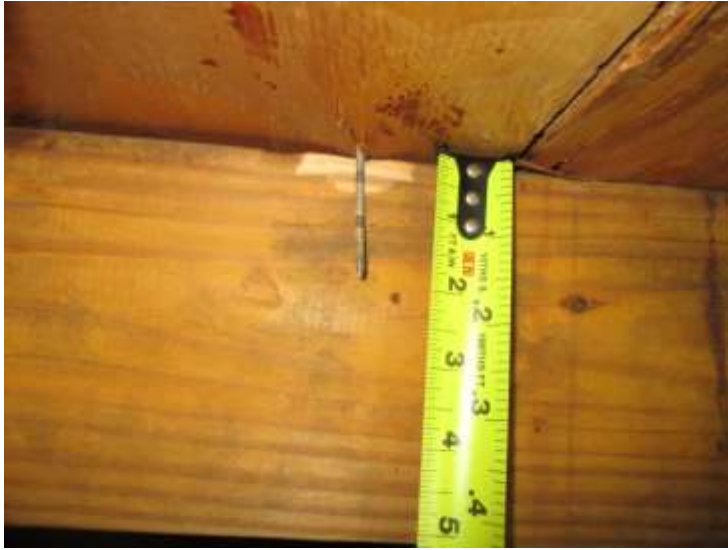
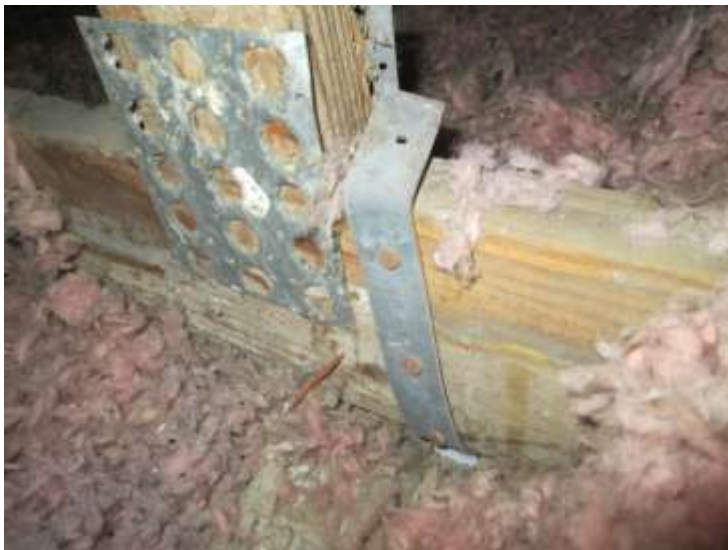
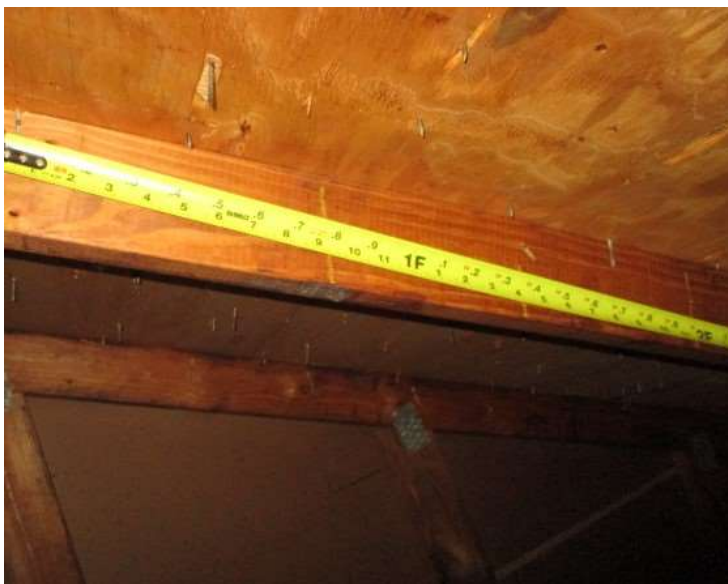
Roof Construction

3. **Roof Deck Attachment:**        **Level B**  
Comments:                                      Inspection verified 1/2" plywood roof deck attached with 8d nails at a minimum 6" on the edge & 6" in the field on the pitched sections. Inspection also verified 1/2" plywood roof deck attached with 8d nails at a minimum of 6" on the edge & 12" in the field on the flat portions.

4. **Roof to Wall Attachment:**        **Clips**  
Comments:                                      Inspection verified embedded straps fastened with a minimum of three nails.

6. **SWR:**                                      **Yes**  
Comments:                                      SWR was verified at time of inspection. The Secondary Water Resistance verified is a self-adhering peel and stick.

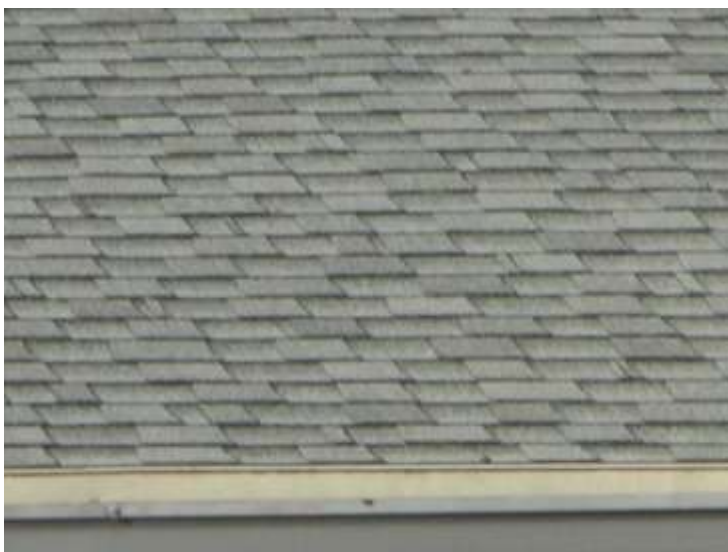
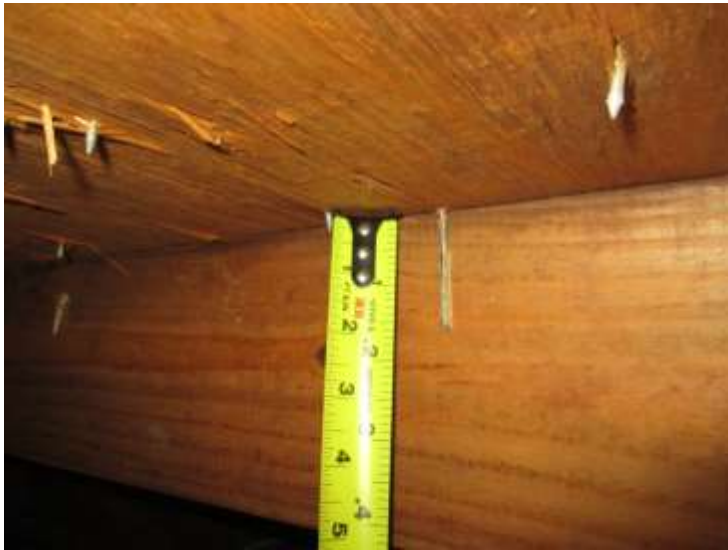
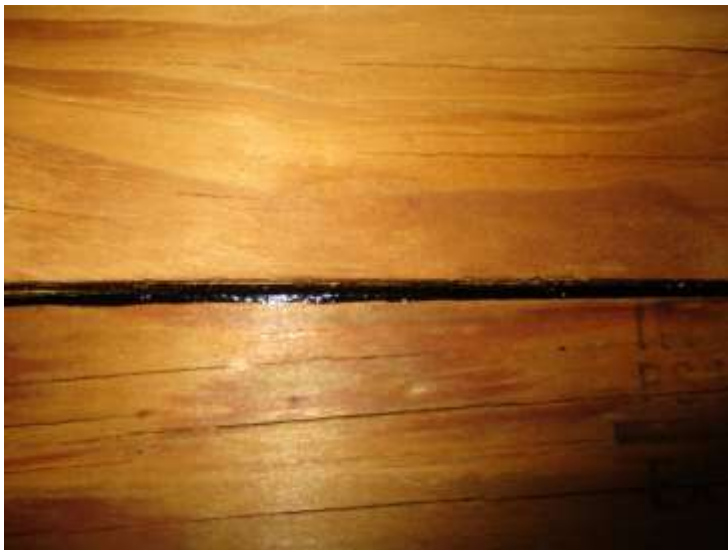
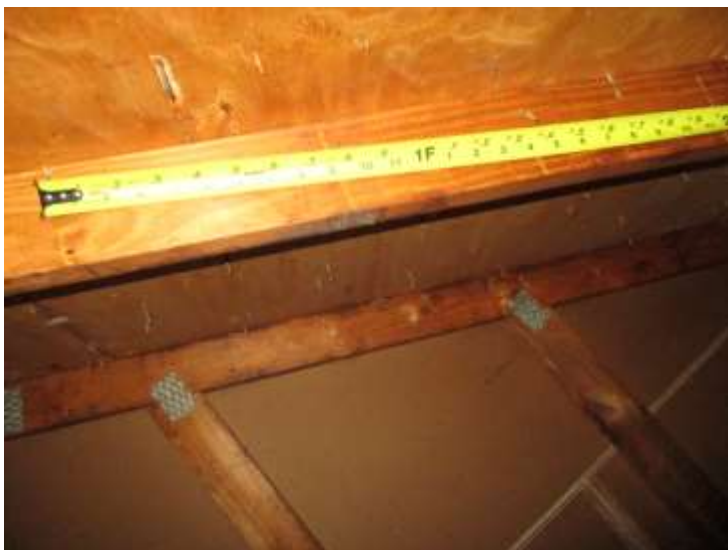
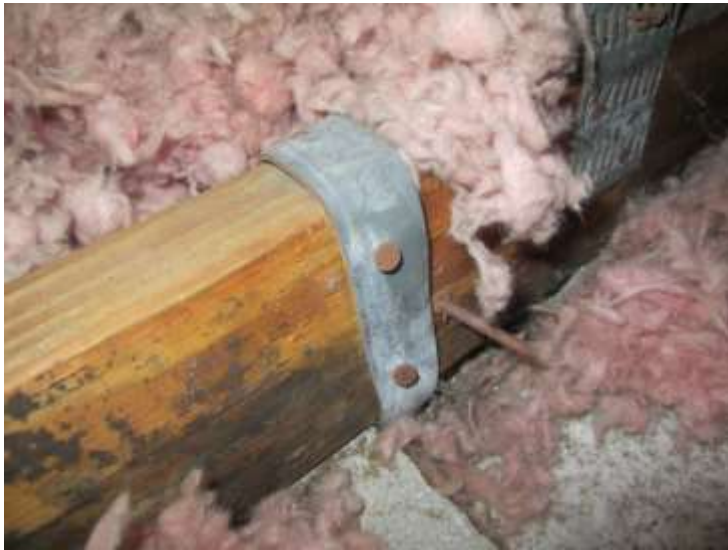
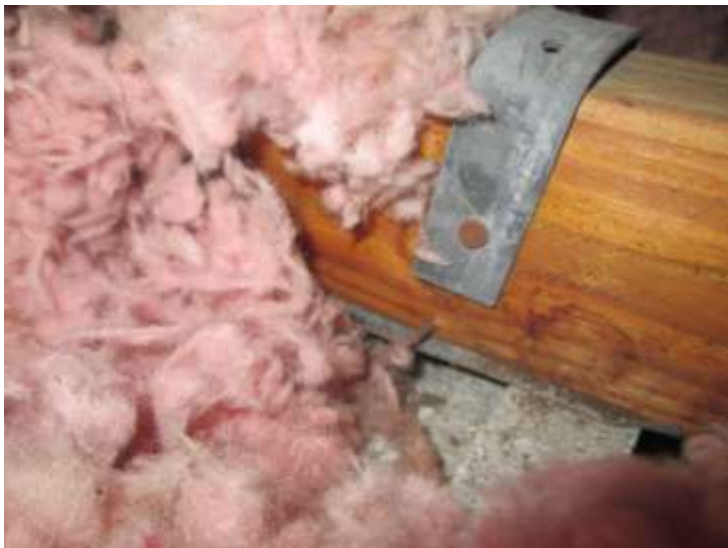
Roof Construction

- 6. SWR:**                                      **Yes**  
Comments:                                      SWR was verified at time of inspection. The Secondary Water Resistance verified is a self-adhering peel and stick.

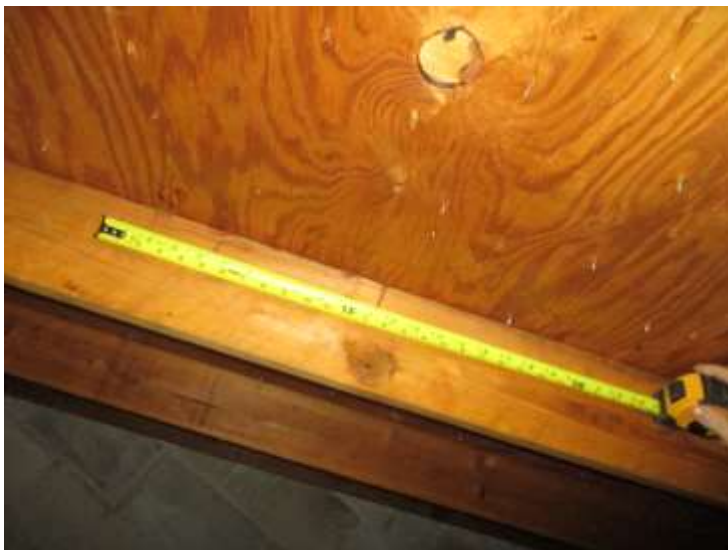
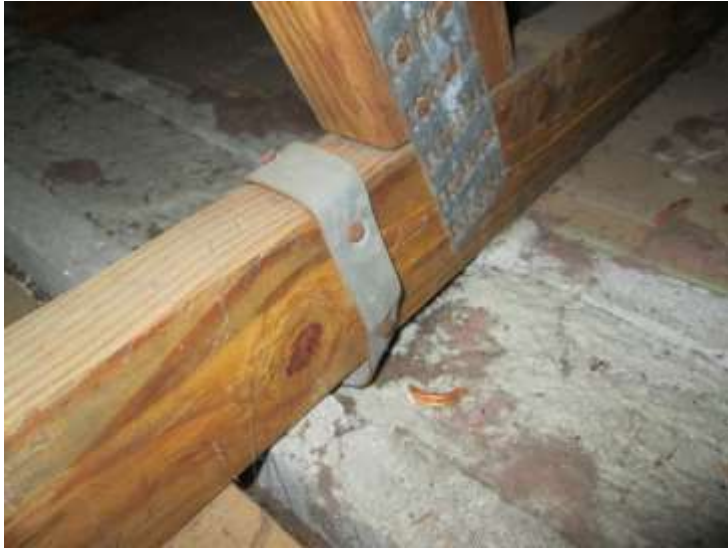
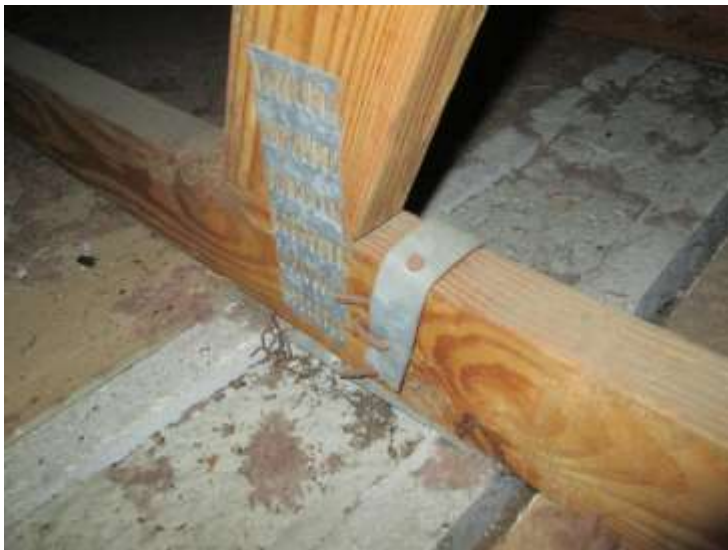
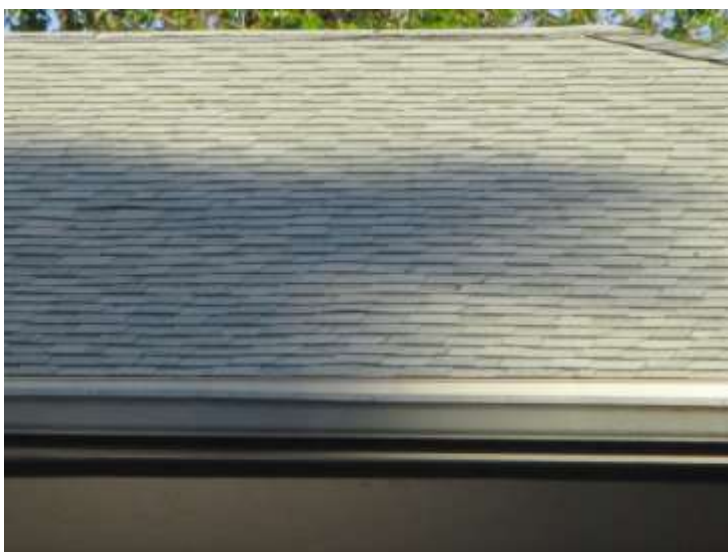
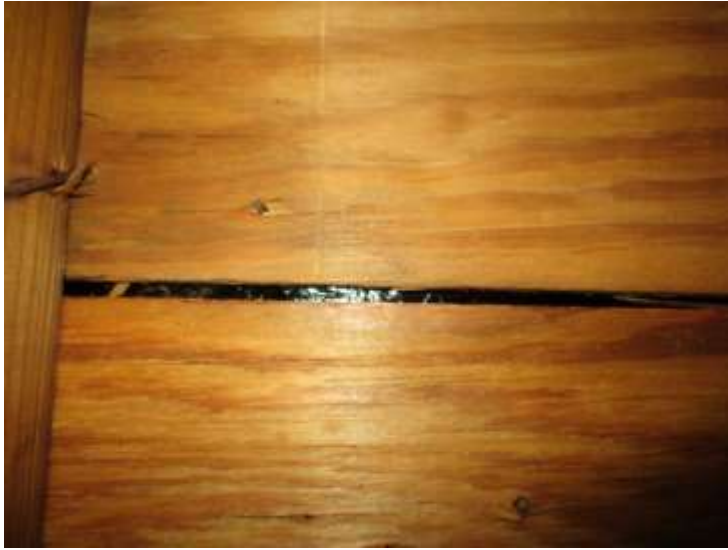
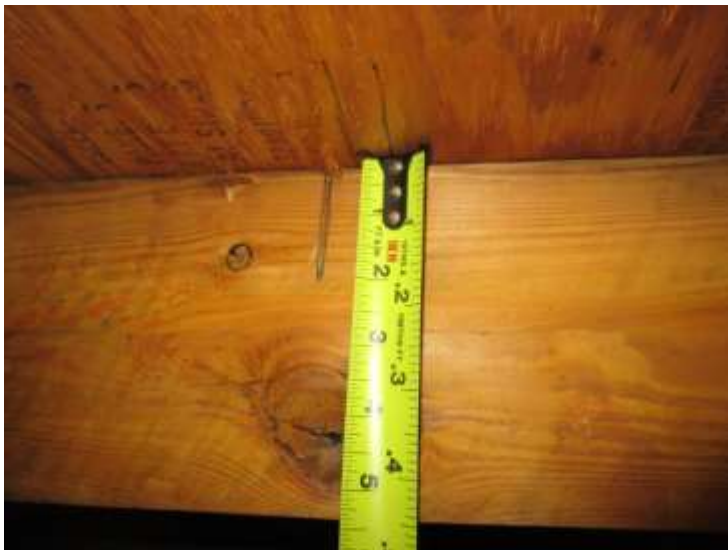
Roof Construction

6. **SWR:**                                      **Yes**  
Comments:                                      SWR was verified at time of inspection. The Secondary Water Resistance verified is a self-adhering peel and stick.
